Texas Abandoned Mine Land Reclamation Projects

RAILROAD COMMISSION OF TEXAS
SURFACE MINING AND RECLAMATION DIVISION

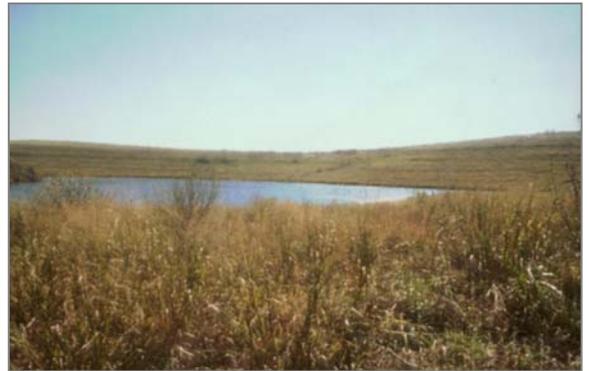
Alcoa Area 11 Post-Construction

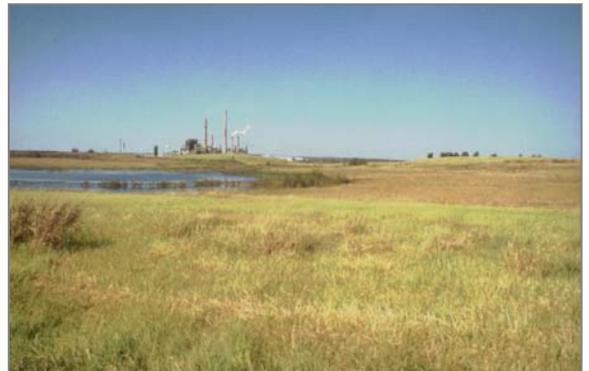
Alcoa Area 9 Post-Construction

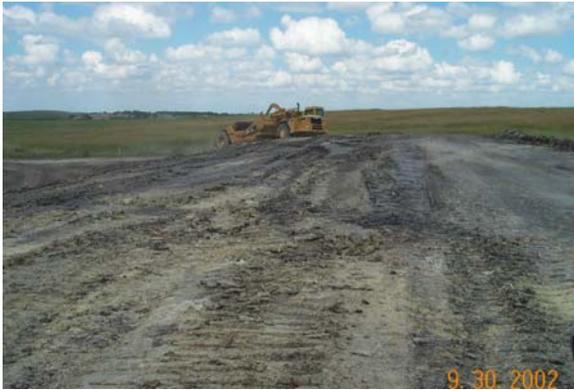
Typical reclamation progression of abandoned uranium mine.

Dozers and scrapers are employed to salvage all topsoil from the disturbance area, prior to any heavy earthwork.

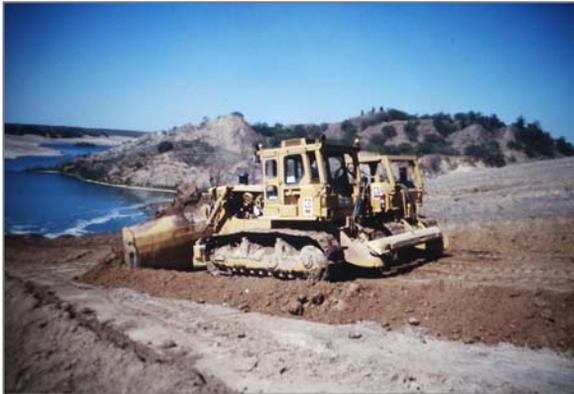
Heavy earthwork equipment is used to place mine spoil back into the abandoned pit.

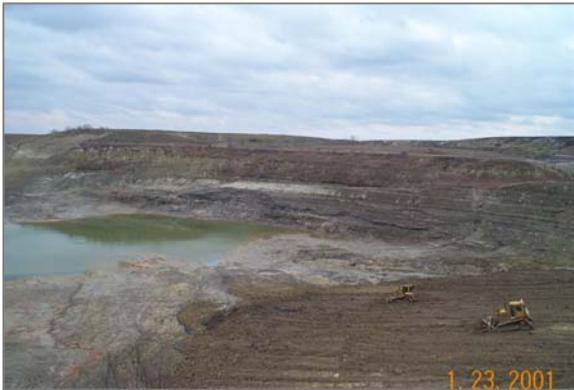
Low ground pressure dozers are used to construct a stable pit floor.

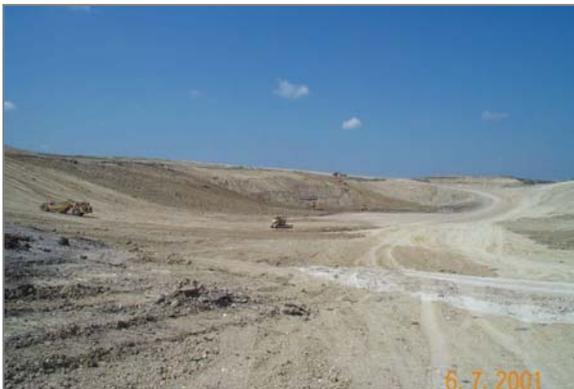
After the pit floor is stabilized, larger excavation equipment is used to flatten the pit walls.

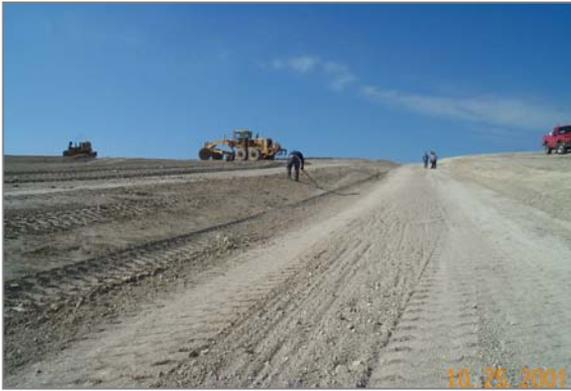
Constructing drainage channels.

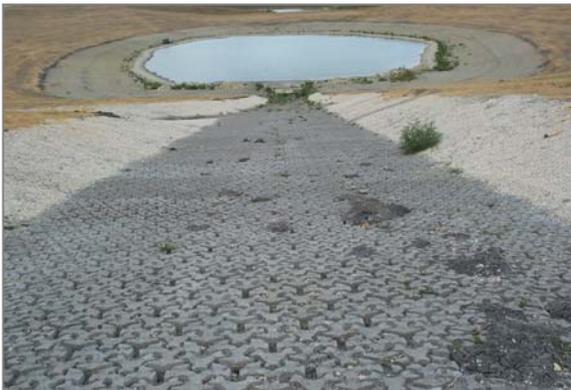
Interlocking blocks are sometimes used to armor drainage channels and establish erosion control.

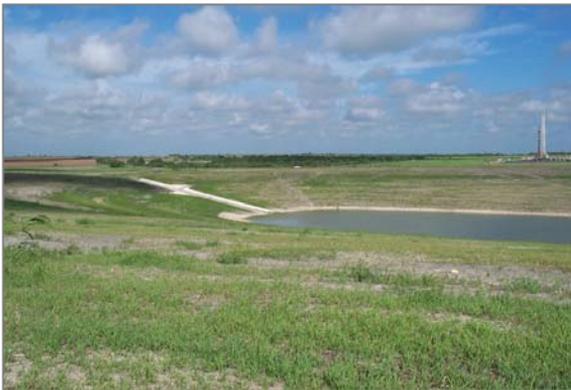
A drainage control network is needed to transport overland flow into the reclaimed pit bottom.

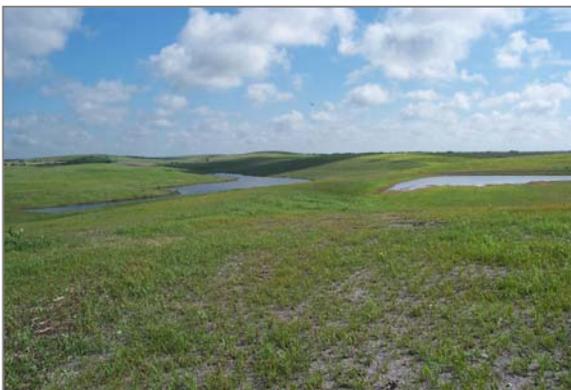
Established grasses hold the soil in place and provide livestock forage.

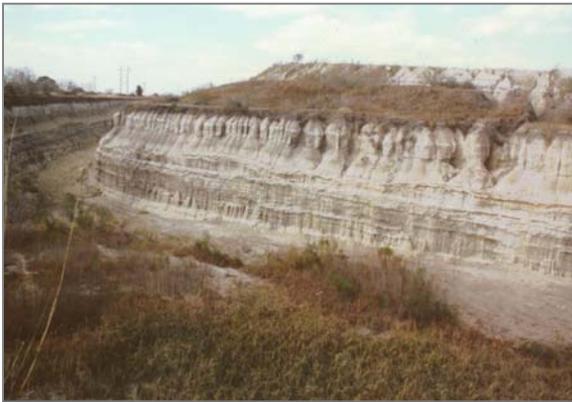
The Elias Brysch site was mined prior to 1973. This AML project consisted of a 10-acre abandoned pit and approximately 8 acres of spoil. The pit highwalls were approximately 40 feet high and were 25 feet from a county road.

E. Brysch Project - Pre-Construction

This project was the Commission's first uranium AML reclamation project. The project was completed in 1988. Approximately 300,000 cubic yards of spoil were moved to totally backfill the existing pit.

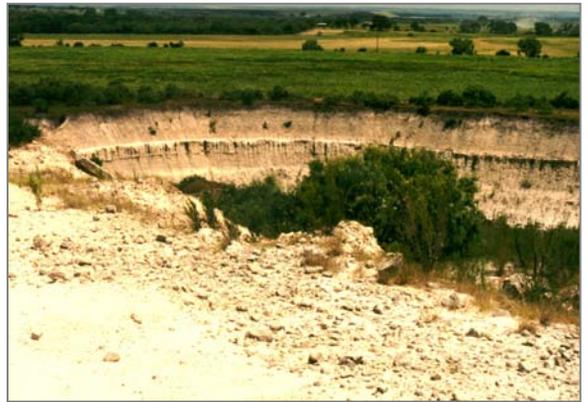
E. Brysch Project - Reclaimed

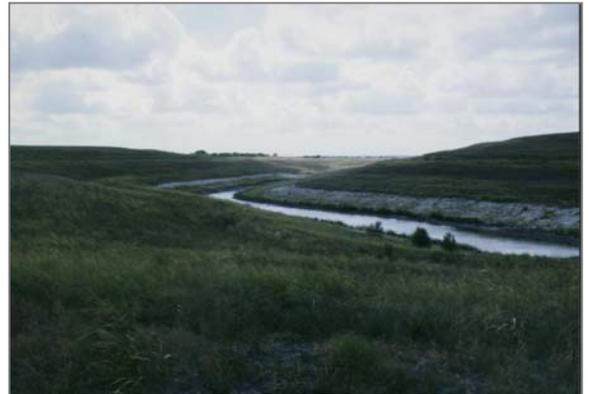
Manka Project - Reclaimed

Regrading and recontouring was completed in 1992. Approximately 915,000 cubic yards of spoil and highwall were moved to achieve the design contours of 20% slopes or less. Revegetation and erosion control was completed in 1994 and was released to the landowner that same year.

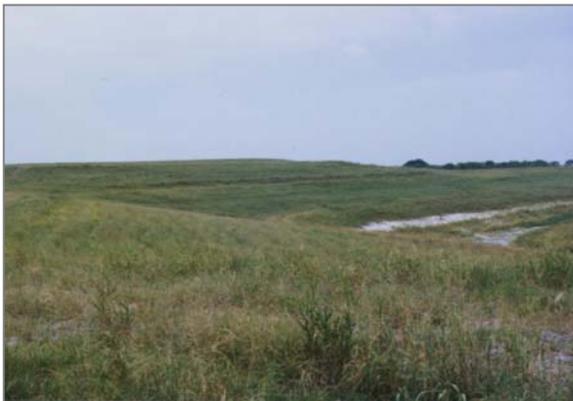
Manka Project - Reclaimed

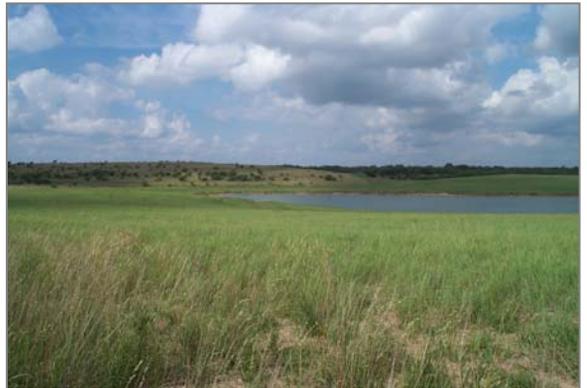
Smith Project - Reclaimed

The second phase of earthwork reclamation was completed in February 2000. Approximately 1,130,000 cubic yards of spoil and highwall were moved to achieve the design contours of 14%. Revegetation of the Phase 2 earthwork was completed in May 2000.

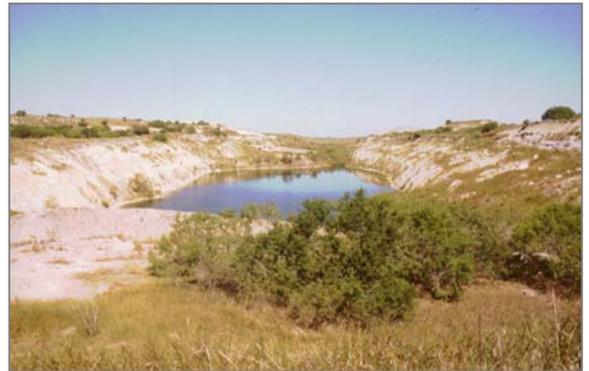
This 153-acre site consisted of a 41-acre pit and 112 acres of spoil. The pit highwalls were unstable and approximately 60 feet high. The pit contained three impoundments. The smallest was less than one acre and approximately 20 feet deep. The largest was 3.5 acres and was about 45 feet deep.

High radiation levels were associated with low-grade ore that had been stockpiled on portions of the spoil. Other portions of the spoil contained acidic materials and elevated concentrations of arsenic, selenium and molybdenum.

Buttler-Weddington Area 2A Pre-Construction

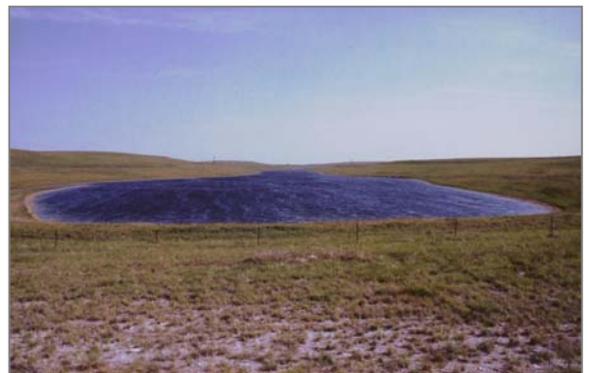
Buttler-Weddington Area 2A Reclaimed

Regrading and recontouring was completed in March 1997. Approximately 1,400,000 cubic yards of spoil and highwall were removed to excavate and bury radioactive spoil and achieve final contours of 14% or flatter. Revegetation and erosion control was completed by June 1997, and the site was released to the landowner in 1998.

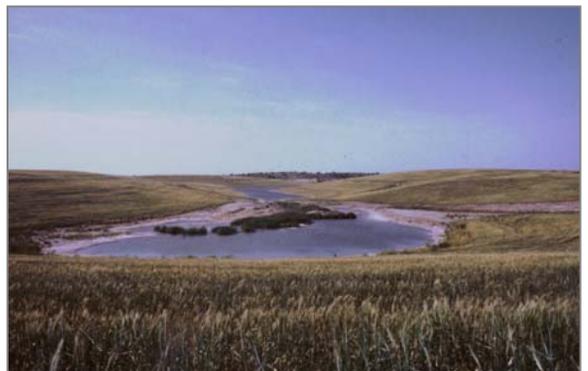
Buttler-Weddington Area 2B Reclaimed

Regrading and recontouring was completed in September 1997. Approximately 1,150,000 cubic yards of spoil and highwall were moved to excavate and bury radioactive and acidic spoil and to achieve the design contours of 14%. Revegetation and erosion control were completed in 1999. The site has yet to be released.

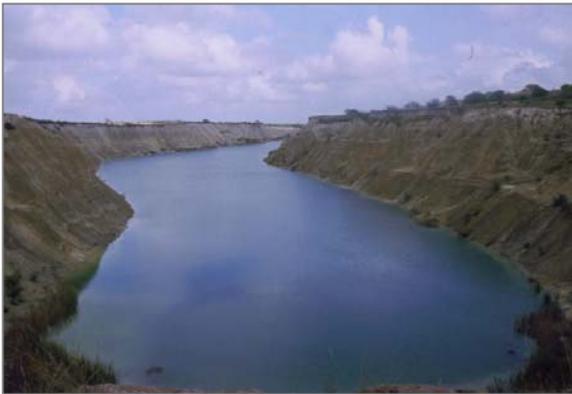
This site consisted of a 40-acre pit and 125 acres of spoil. The pit highwalls were unstable and averaged 90 feet high. Spoil piles averaged 70 feet high. The pit impoundment was 30 feet deep.

Buttler-Weddington Area 4
Pre-Construction

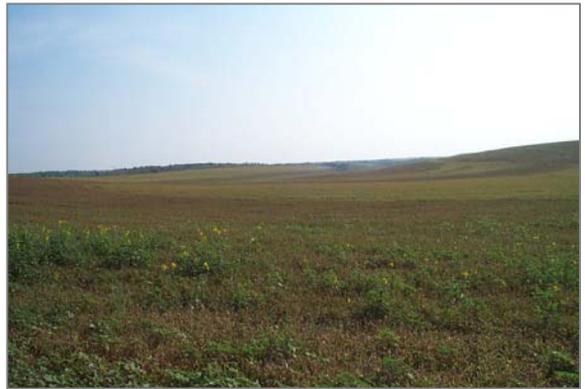
Buttler-Weddington Area 4
Reclaimed

Regrading and recontouring was completed in February 2000. Approximately 200 million gallons of pit water were pumped to an adjacent pit before the earthwork could begin. Approximately 2.6 million cubic yards of spoil and highwall were moved to achieve the design contours of 14% or flatter. Revegetation and erosion control is in progress.

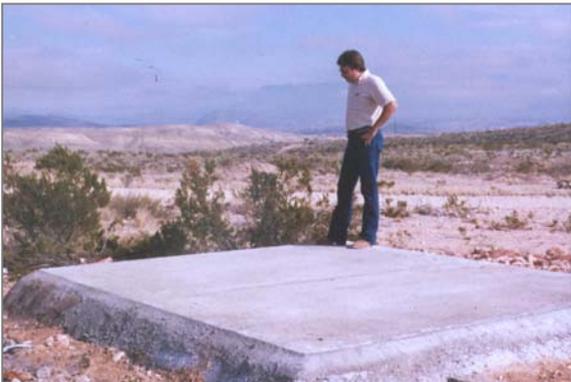
Terlingua mine shaft with concrete cap closure

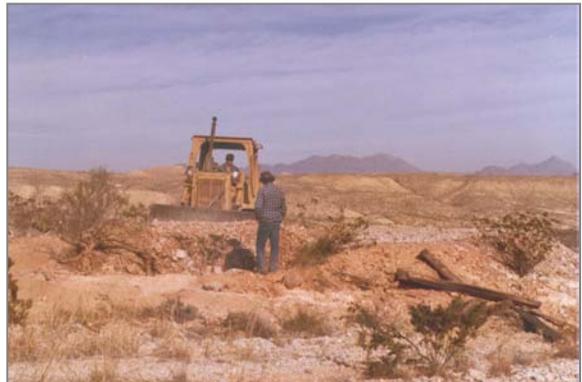
Terlingua mine backfilled shaft

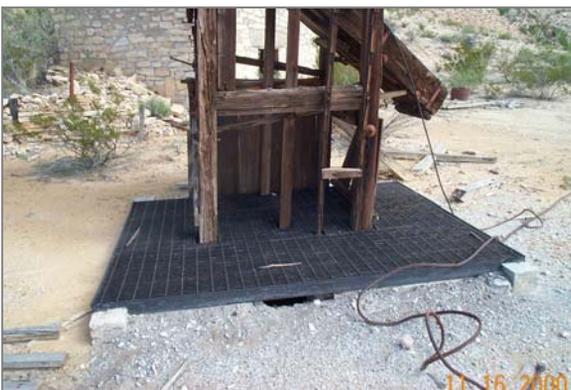
Terlingua mine shaft with steel grate closure

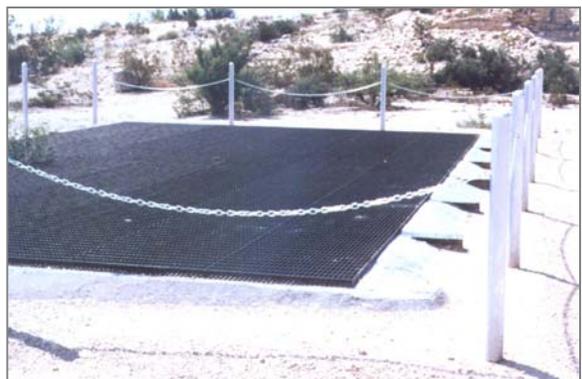
Terlingua mine shaft with steel grate closure

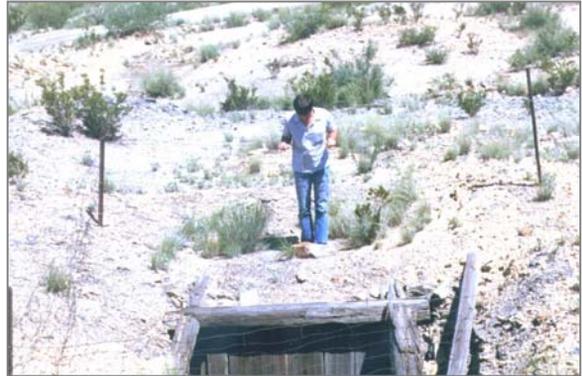
Study Butte – typical mine shaft openings

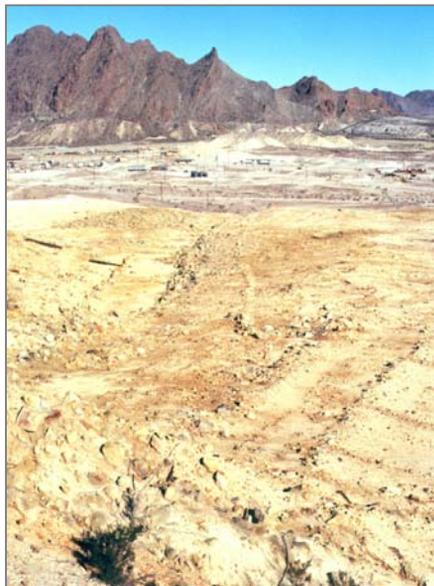
Study Butte backfilled mine shaft

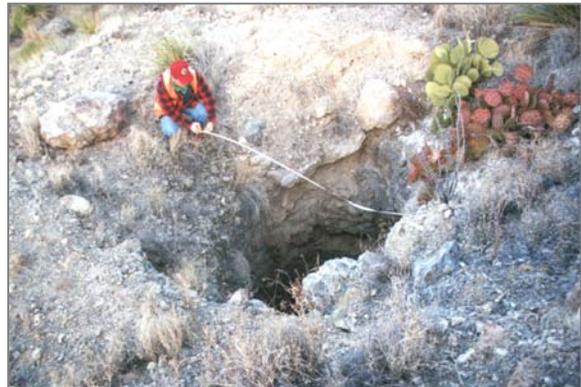
Christmas Mountain - typical mine adit & shaft openings

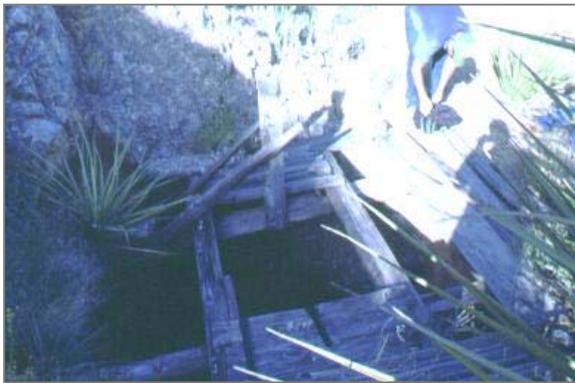
Christmas Mountain open mine shaft

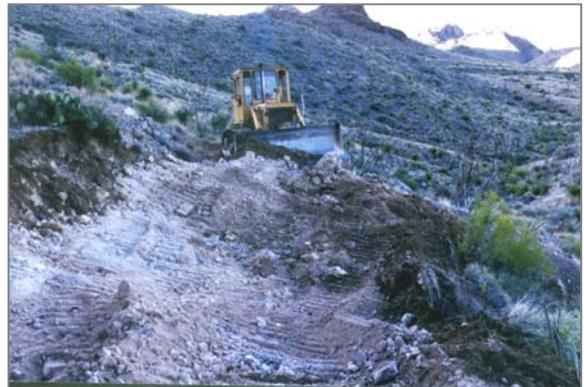
Christmas Mountain mine shaft being backfilled

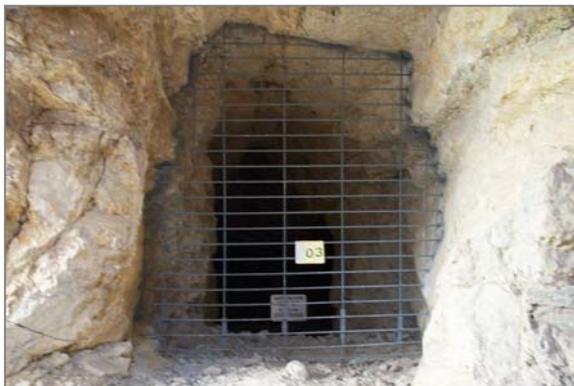
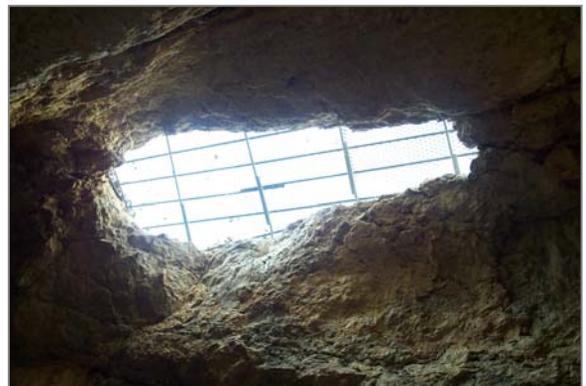
Christmas Mountain – typical rebar closures

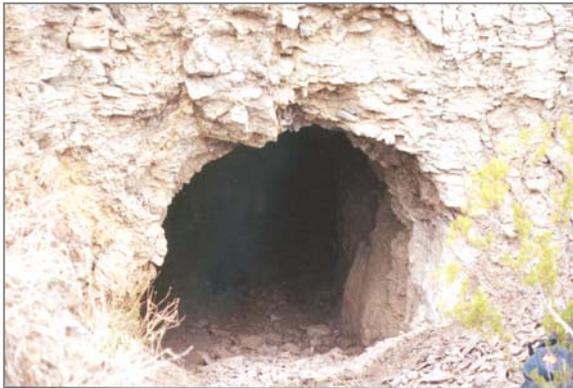
Big Bend National Park – typical adit

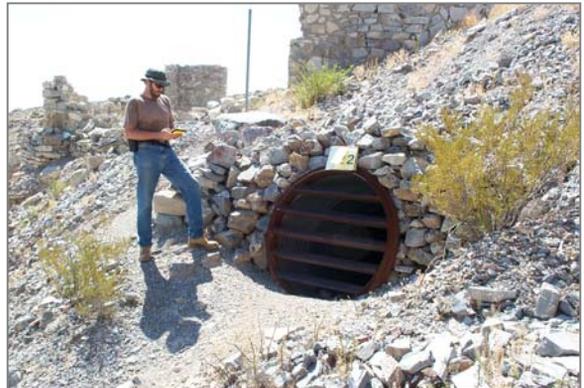
Big Bend National Park - adit with angle-iron bat gate closure

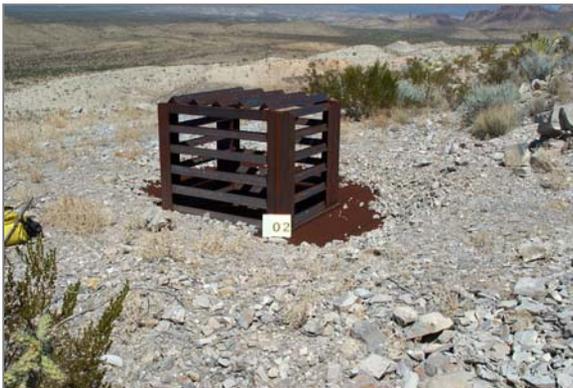
Big Bend National Park –mine shaft with angle-iron bat cupola closure

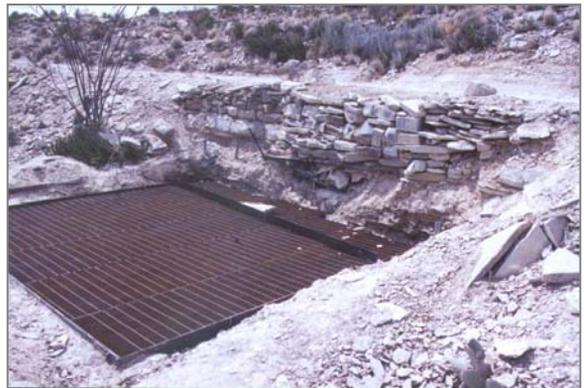
Big Bend National Park – mine shaft with steel grate closure

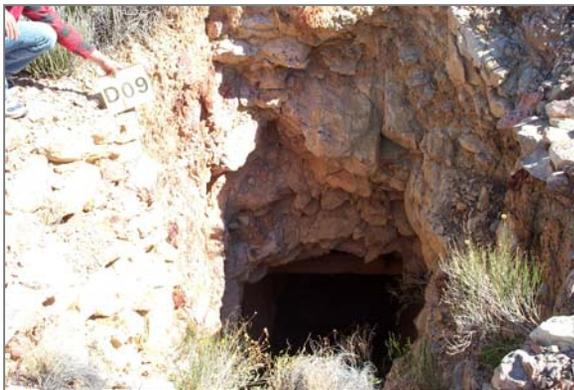
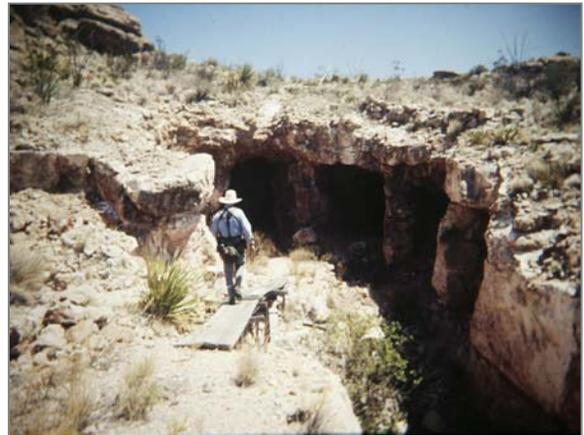
Lone Star-Mariposa – open mine adits

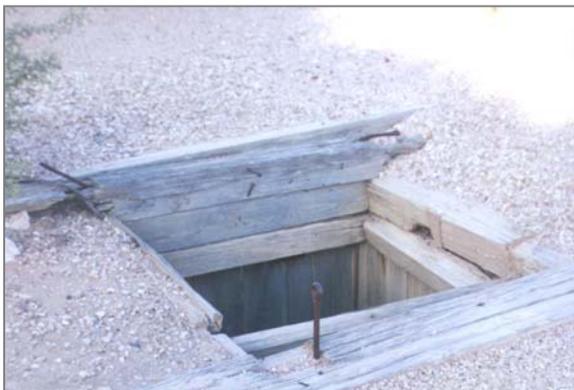
Lone Star-Mariposa – open mine shafts

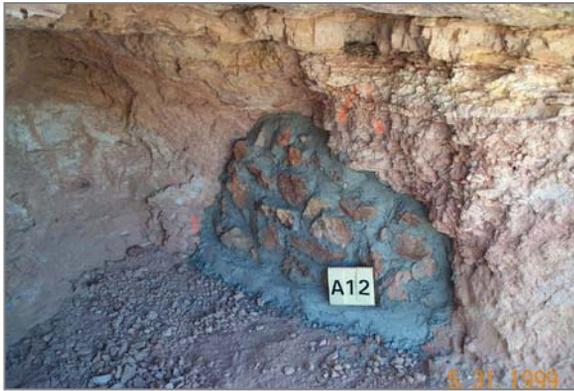
Lone Star-Mariposa adit with rock mortar wall closure

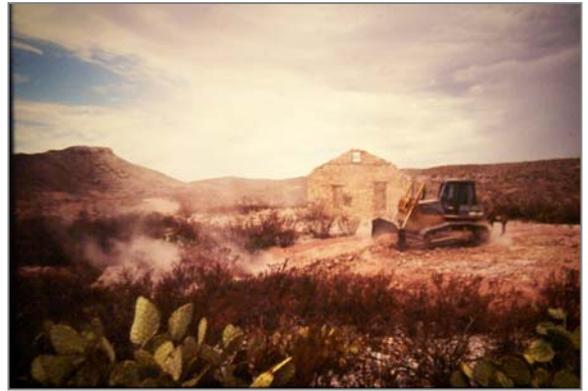
Lone Star-Mariposa mine shaft being backfilled

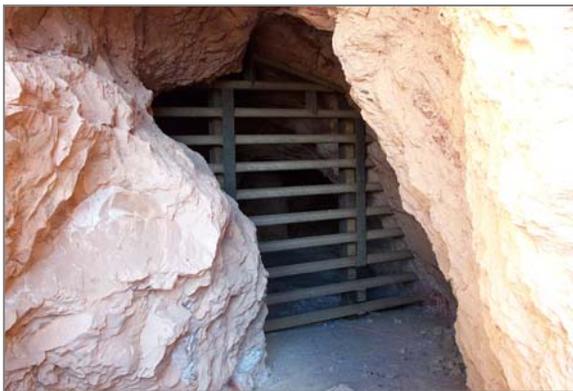
Lone Star-Mariposa adit with bat gate closure

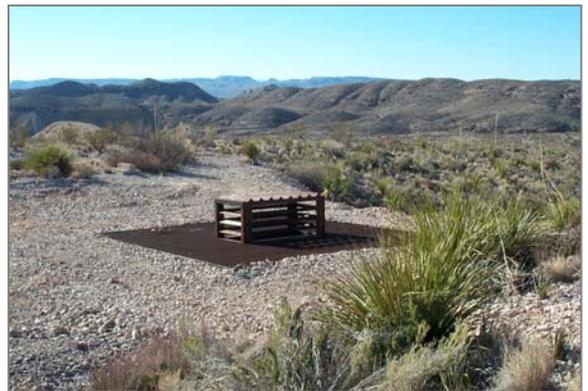
Lone Star-Mariposa mine shaft with steel grate closure

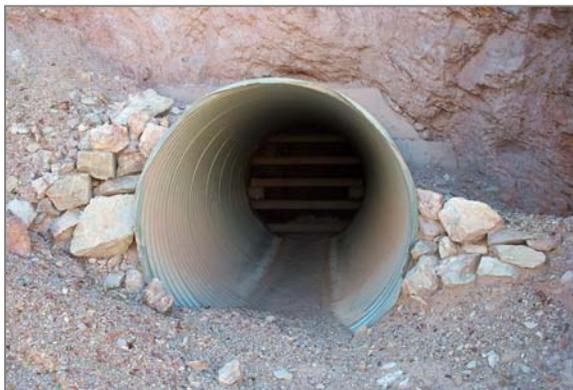
Lone Star-Mariposa portal with bat gate closure

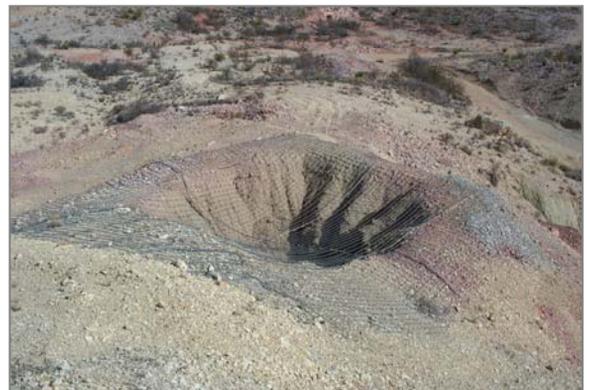
Lone Star-Mariposa mine shaft with cable-net closure

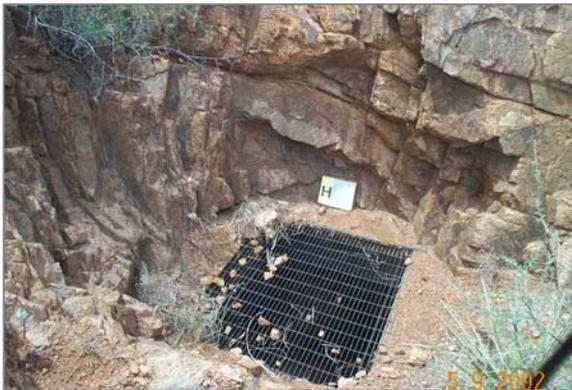
Franklin Mountains – steel grate closure

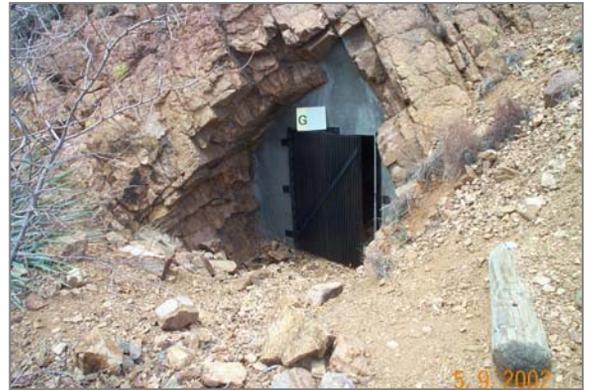
Franklin Mountains – steel grate closure

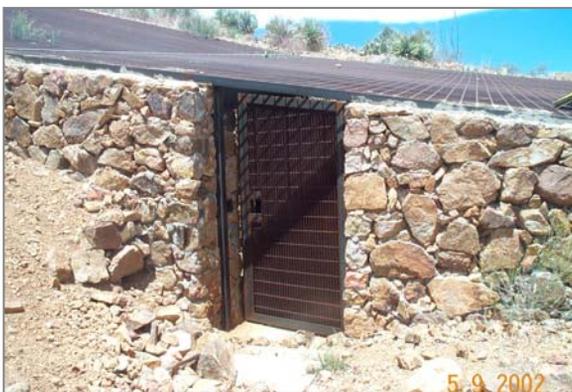
Franklin Mountains – steel grate closure

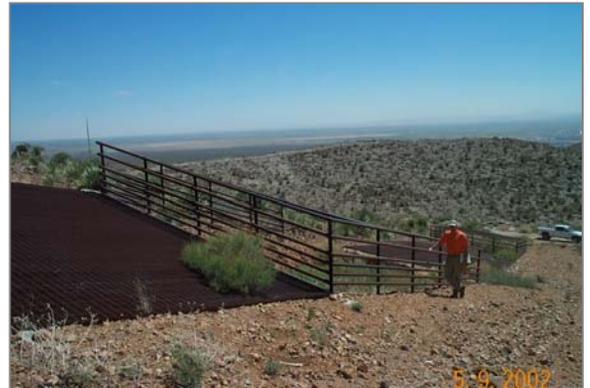
Franklin Mountains – steel grate closure

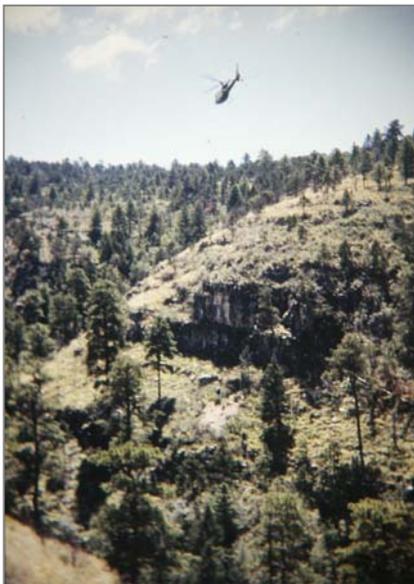
Materials being air lifted in

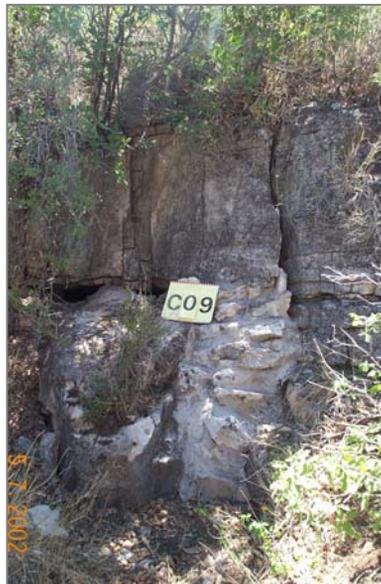
Rock and mortar closure

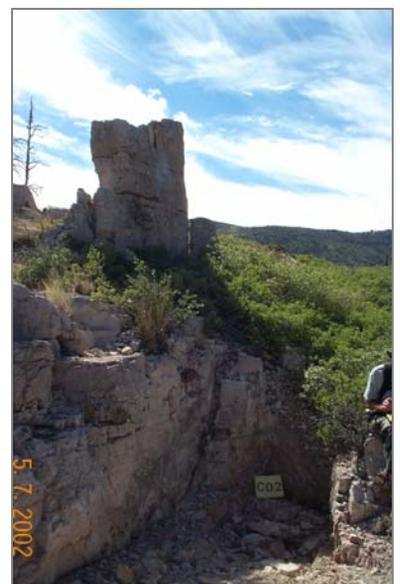
Backfilled mine shaft

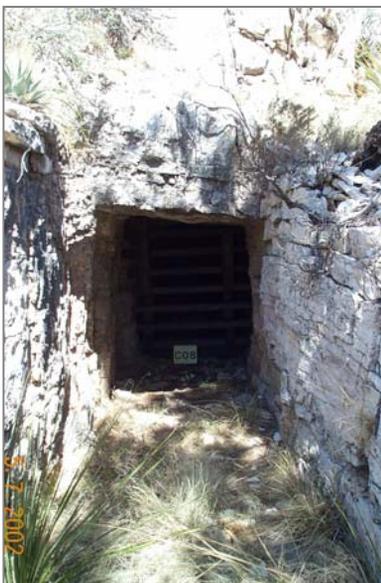
Bat gate closure

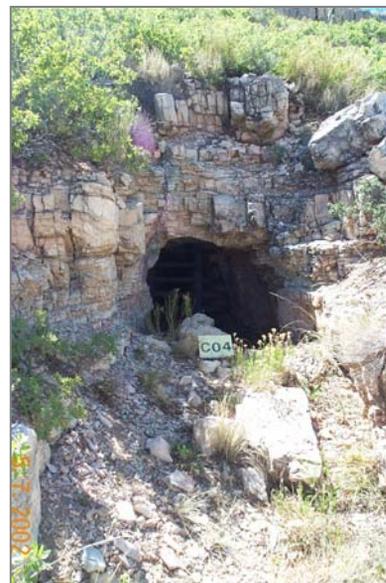
Bat gate closure

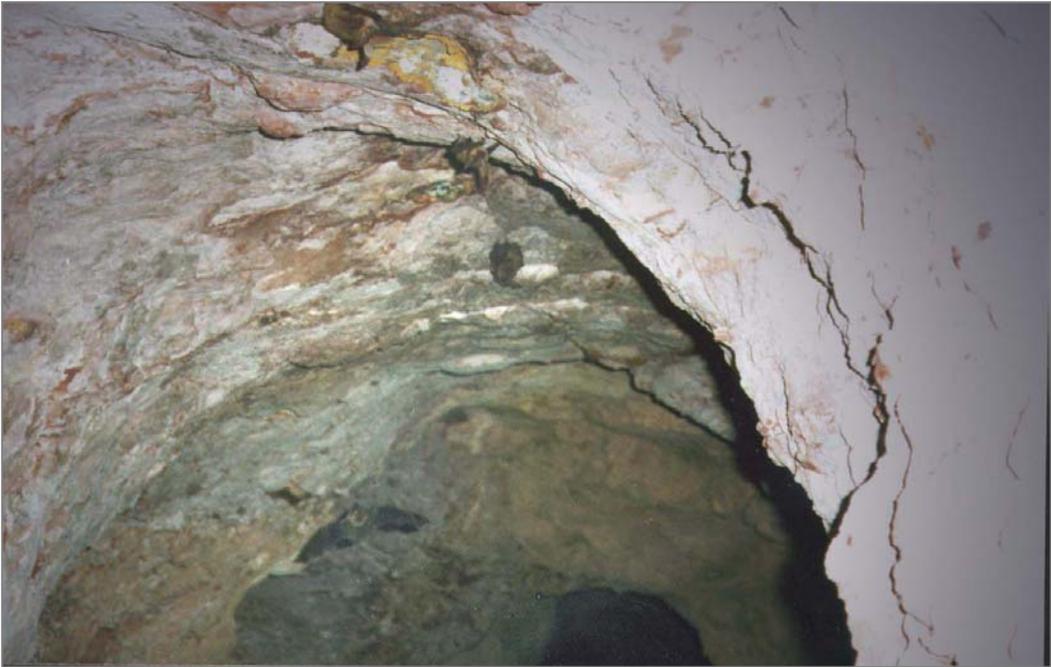
Mariposa mine with occupying bat colony

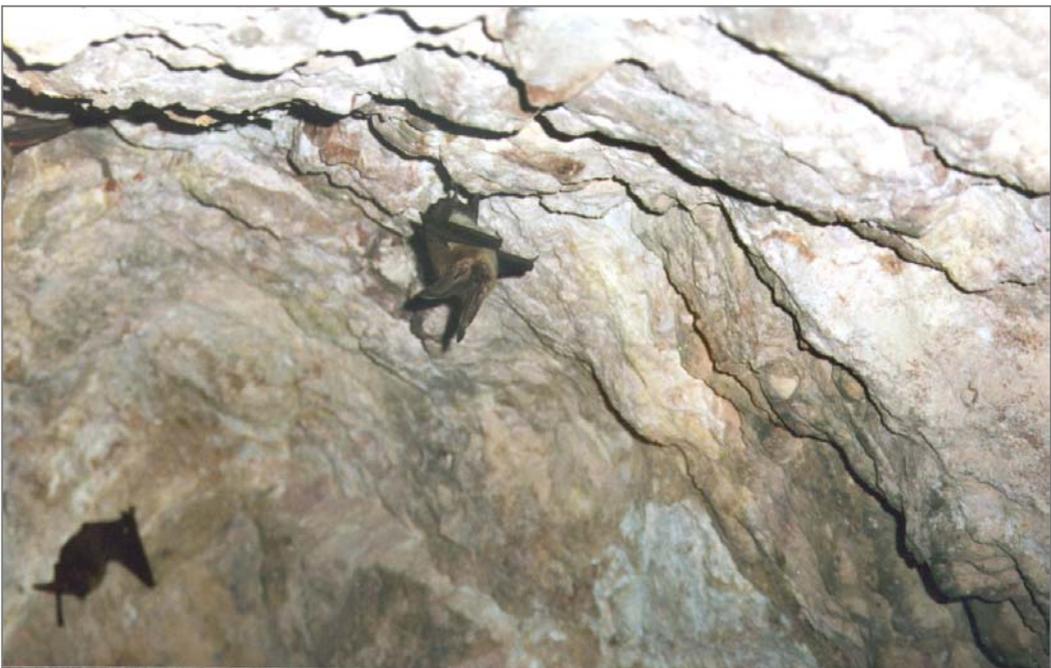
Mariposa mine with occupying bat colony

Bat gates – closure structures with openings that allow bats roosting within the mine to enter and exit the mine opening.

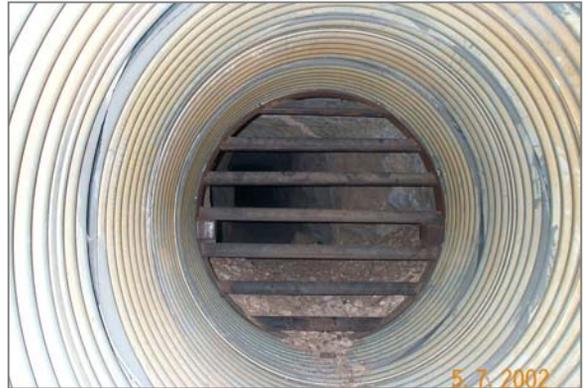
Portal with corrugated metal pipe and angle iron bat gate closure

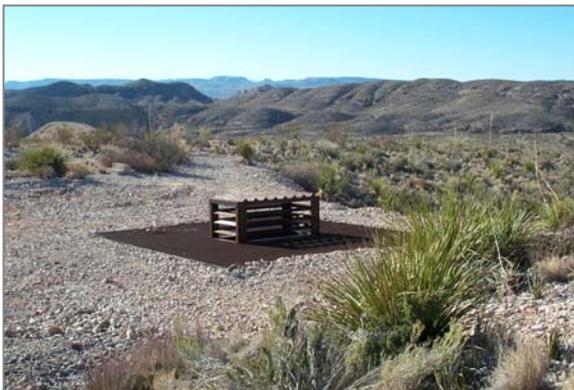
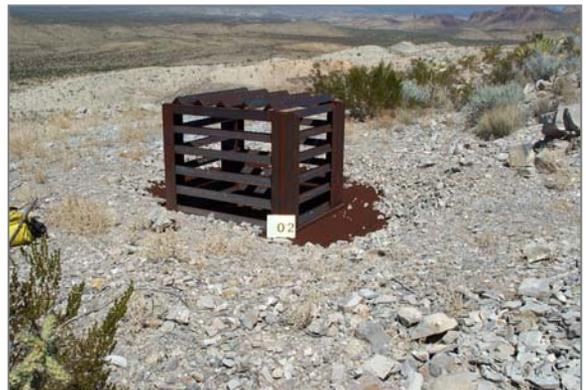
Mine shaft with angle iron bat gate cupola closure

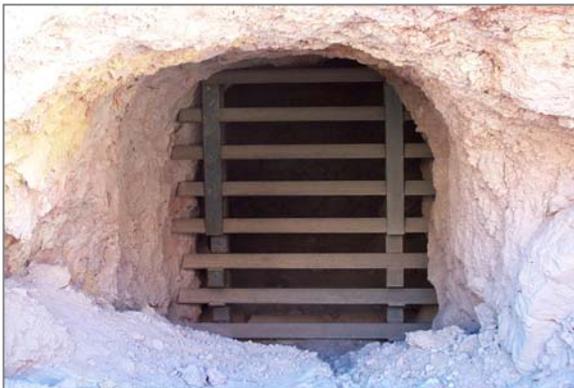
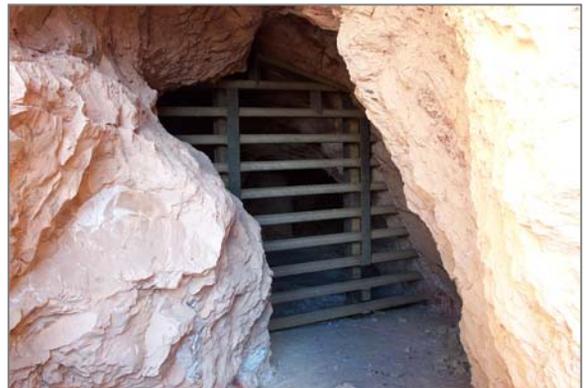
Portal with angle iron bat gate closure
